Manhole Inspection Summary

Manhole # S33GG_010MH

Insp Date: **2/16/07 9:35 AM**

Location Address: **1319 MT ROYAL AVE**

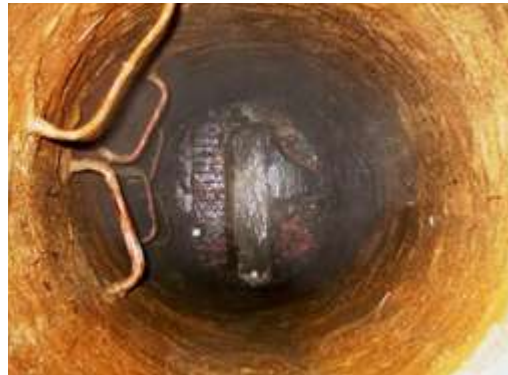
Top View

Corroded steps. Evidence of surcharge - Bench debris.

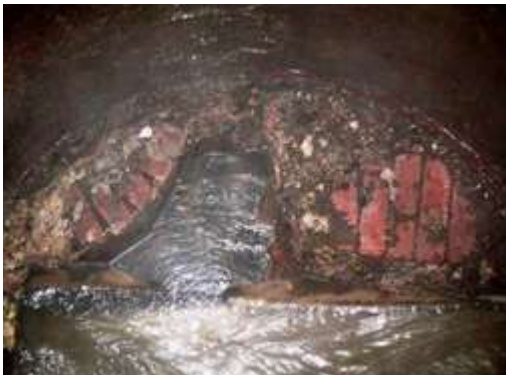
Defect

Capped I3.

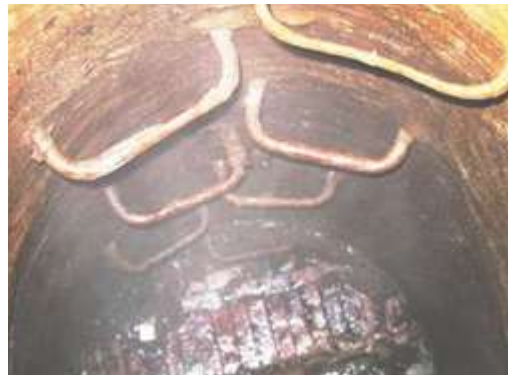
Defect

Adjustment, Corbel and Barrel infiltration.

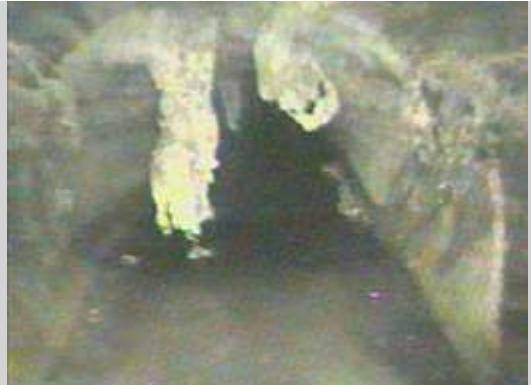
12 in. Circular Gravity Sewer Pipe Out @ 12 O'Clock

Infiltration: **None** Pipe Seal Cond: **Roots**

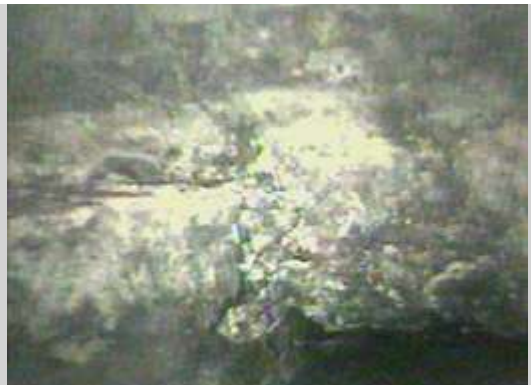
Pipe In @ 3 O'Clock

Capped line.

Connects To: **Stub connection / abandoned**
